Natural Gas Leaks of Significant Environmental Impact (SEI)

Report of the 2018 SEI Field Trial

Utilities Enacting the Leak Extent Method

March 2019

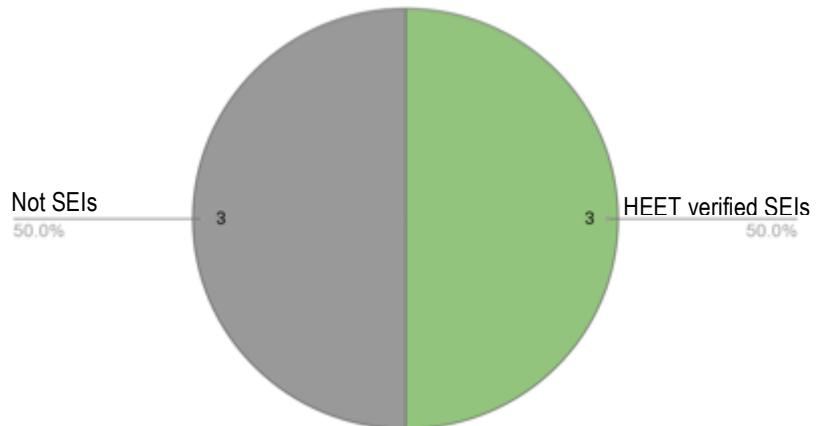
The *estimated* leak extent was not very accurate. The HEET-measured leak extents turned out to be on average less than half of the required 2,000 square foot extent of an SEI. Of the six HEET measured, only 3 of them were verified to be SEIs.

2018 Pilot Year, 6 Columbia Gas *estimated* SEIs, 50% verified by HEET to be SEIs

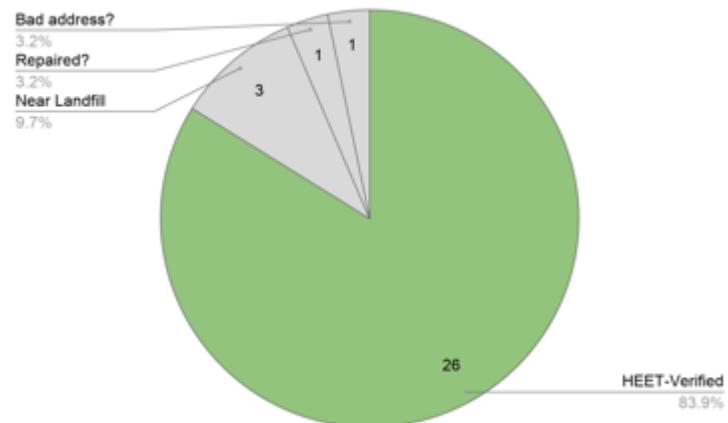
The remaining five leaks either had an unclear address, the leak might have been already repaired, or the leak was close enough to a town dump that the source of the methane in the soil was not certain to be natural gas. In none of these cases was there a problem with the protocol.

2018 Pilot Year, 31 Eversource-identified SEIs, 84% verified by HEET to be SEI

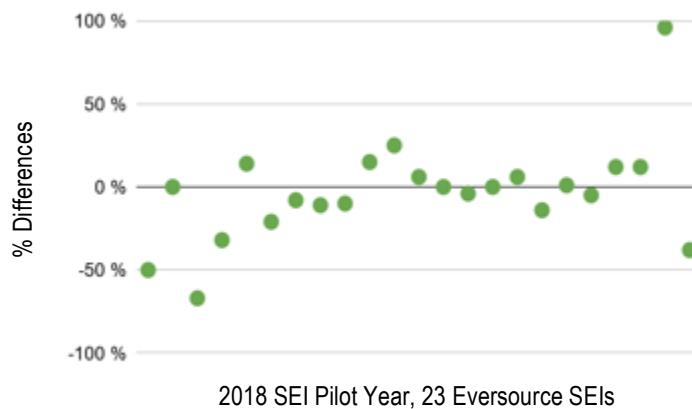
On average, the difference was very small - just 3%, in spite of the fact that:

The leak extent measurement at individual leaks remained relatively consistent, over an average of four months, even when the same leak was measured by different personnel from two different organizations. This method appears to be robust.

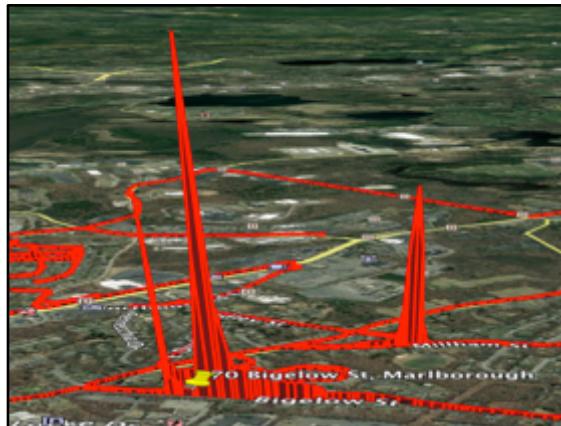
This image shows Belknap Road at Grove Street, Framingham, MA. Orange pin shows an Eversource identified SEI which lines up perfectly with a CRDS-sensed methane peak.

A known leak aligns with CRDS mobile survey data

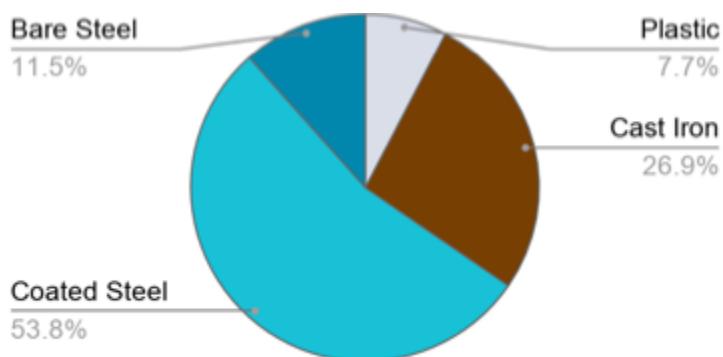
2018 SEI Pilot Year, 24 SEIs, Eversource territory

Coated steel and cast iron pipes appear to be more likely to develop SEIs, especially when compared to the material distribution of the Eversource territory below. More data is needed to confirm this tendency.

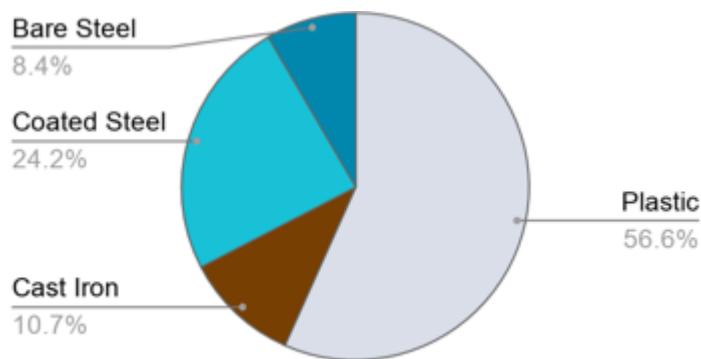
2017 Eversource Gas System Enhancement Plan, Pipe Materials for All of Eversource Territory (Source: D.P.U.17-GSEP-06)

While there were hardly any SEI leaks found on plastic pipes during the pilot year, Eversource territory as a whole has over 50% plastic pipes. This difference suggests that plastic pipes are less likely to develop SEIs.

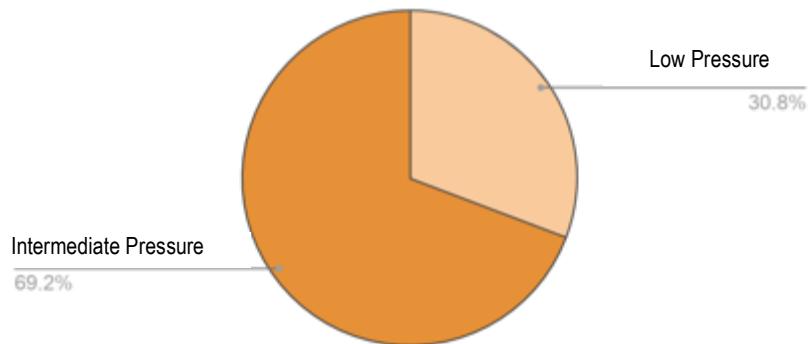
2018 SEI Pilot Year, 26 SEIs, Eversource territory

More SEIs occurred on intermediate pressure pipes than on low pressure. We did not have information on pipe pressure across the entire Eversource territory to use as a reference and give this result more meaning.

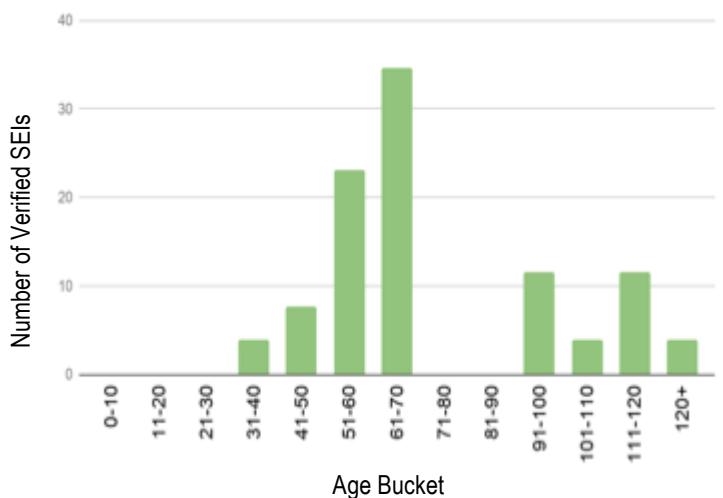
We examined the distribution of the 26 SEIs by the age of the pipe installation. We did not have information on ages of pipes across the entire Eversource territory to compare this with. Both median and modal age was 63, and the average was 73. We suggest that the gap in the 71-91 years old range is possibly due to no new pipes being installed because of World War II, and the spike around 60 years old is possibly due to a building boom leading to an increase in the number of pipes being installed at that time.

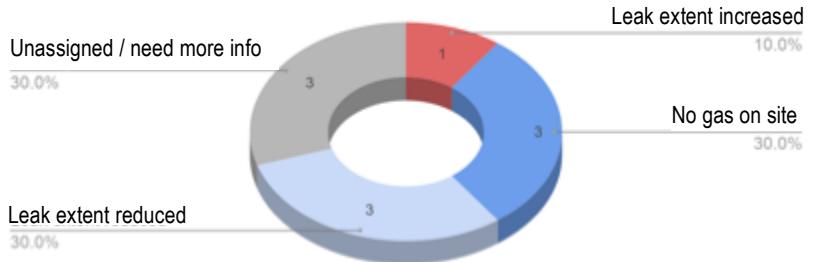
Of the 62 leaks shared with us, 19 leaks were reported repaired by the utilities. To allow all residual gas to leave the soil in the area, HEET returned to 12 of these leaks at least a month after repair²⁶ to check for the presence of gas. If there was any, we recorded if the leak extent was smaller, the same, or larger. (We did not consider methane readings found in a sewer as part of a leak extent (since the readings could potentially derive in part from decomposition rather than natural gas.)

The distribution of leak repair results mirrored results from last year's 2017 Large Volume Leak Study. Both times, only 30% of the repairs seem to be successful enough that there was no gas at the site. The data set is much too small to be conclusive, but it is a concerning trend.
